GENERAL INFORMATION

<i>EWST report #</i>	EW1251
<i>Inspection date</i>	June 20, 2019
<i>Client name</i>	XXX
<i>PO number</i>	XXX
<i>Style number</i>	XXX
<i>Total quantity ordered</i>	340 units
<i>Quantity ready to inspect</i>	340 units
<i>Total inspected</i>	50 units, 14.71%
<i>Exported destination</i>	USA

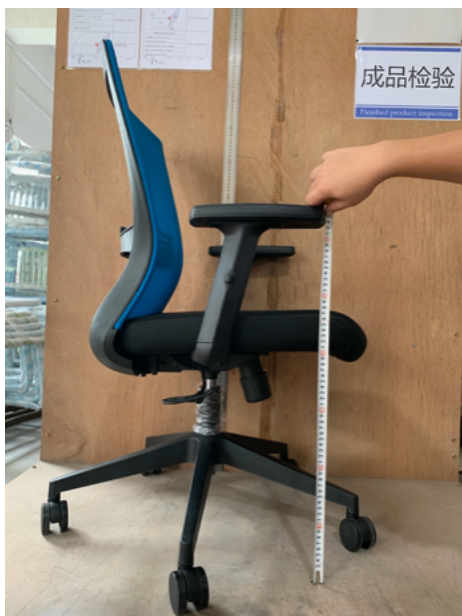
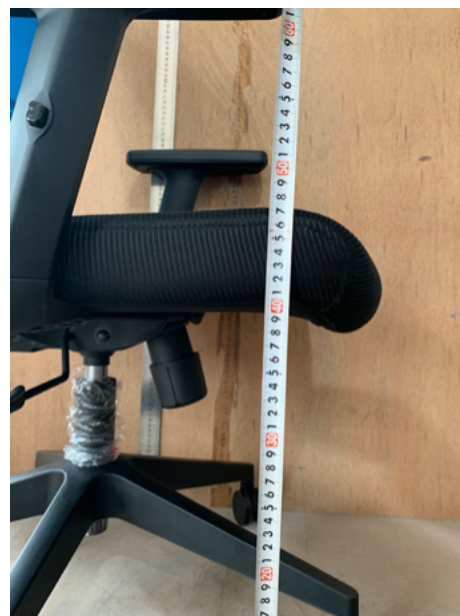
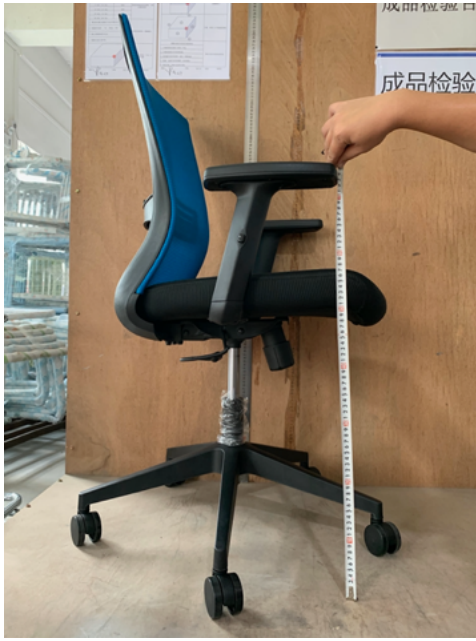
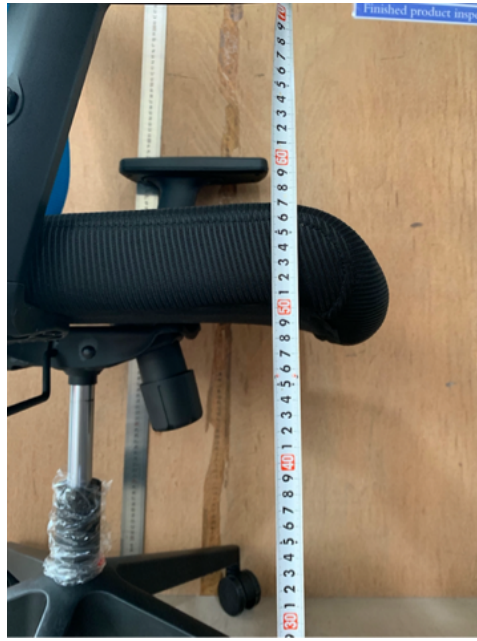
- Seat Height/General Remark:** seat height is approx. 1cm higher than provided measurement chart standard. See pictures #5 - #8 on pages 4 and 5. For other measurements, please refer to pictures #1 - #14 on pages 4 and 5.
- Mold Marks/General Remark:** same as per previous orders, mold marks found on the back side of the chair underneath the frame. While these marks are unavoidable, EWST team instructed the factory to smoothen out all the marks and add black spray if needed. See pictures #13 - #15 on page 6.
- Creases: the fabric on the seat had a slight crease in the centre, repaired on site. See picture #16 on page 6.
- Color Quality/General Remark:** the production's new blue color is very close to the last production's color. See pictures #17 - #18 on page 6.

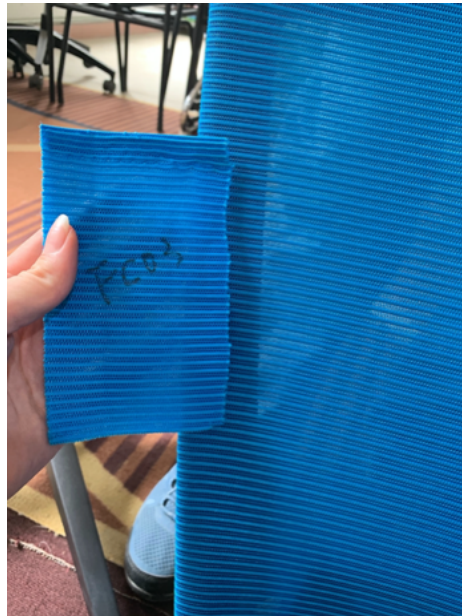
#17

Left: last production's color swatch vs Right: current production

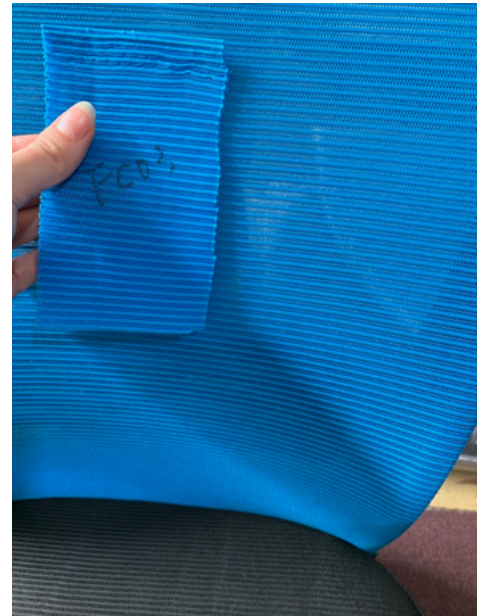
#18

Left: last production's color swatch vs Right: current production

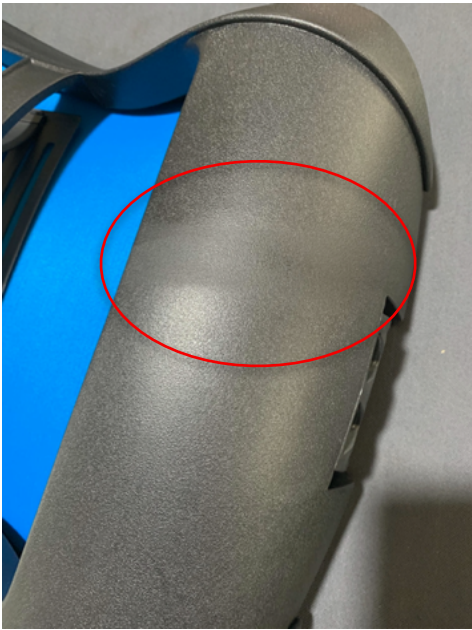
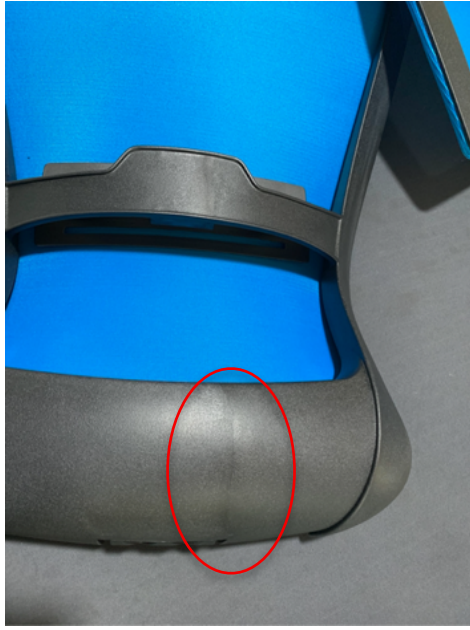
6. Frame Quality: the backs of three frames looked slightly brushed off, having the line. All three frames were replaced, see pictures #19 - #20 on page 7.
7. Uncut Threads: repaired on site. The factory was instructed to go through all the production again and check for uncut threads. See pictures #21 - #22 on page 7.
8. Scratches: minor, repaired on site. See pictures #23 - #26 on pages 7 and 8.
9. Stains: cleaned on site, see pictures #27 - #28 on page 8.
10. Sharp Edges: repaired on site, see pictures #29 - #30 on page 8.
11. Wheel Functionality: one castor was not functioning very smoothly, repaired on site.
