GENERAL INFORMATION

<i>EWST report #</i>	EW1251
<i>Inspection date</i>	June 20, 2019
<i>Client name</i>	XXX
<i>PO number</i>	XXX
<i>Style number</i>	XXX
<i>Total quantity ordered</i>	340 units
<i>Quantity ready to inspect</i>	340 units
<i>Total inspected</i>	50 units, 14.71%
<i>Exported destination</i>	USA

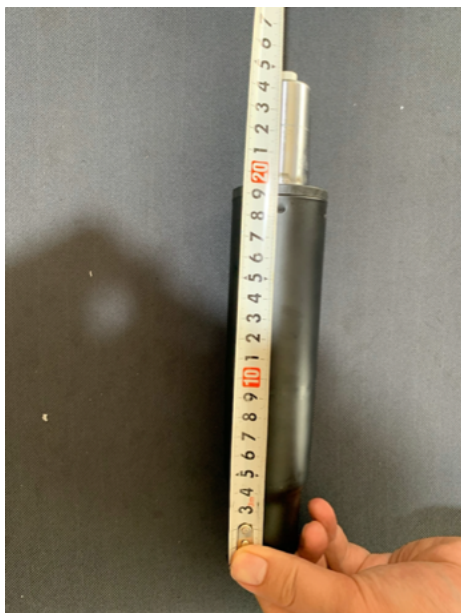
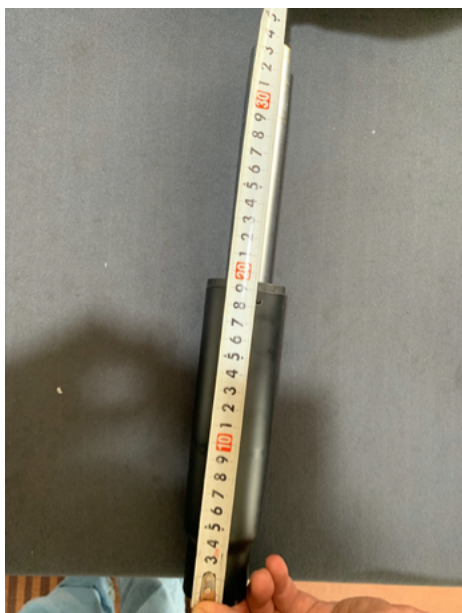
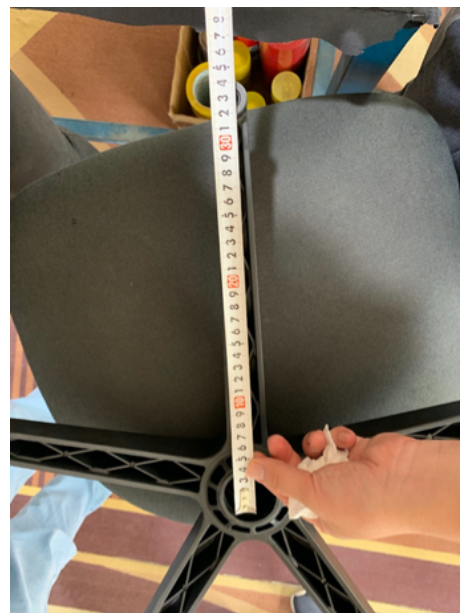
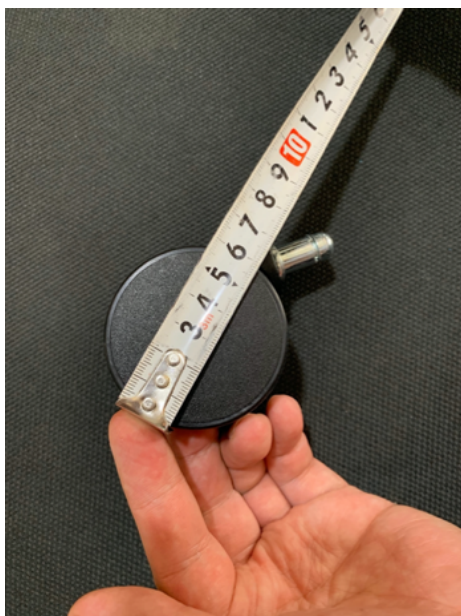
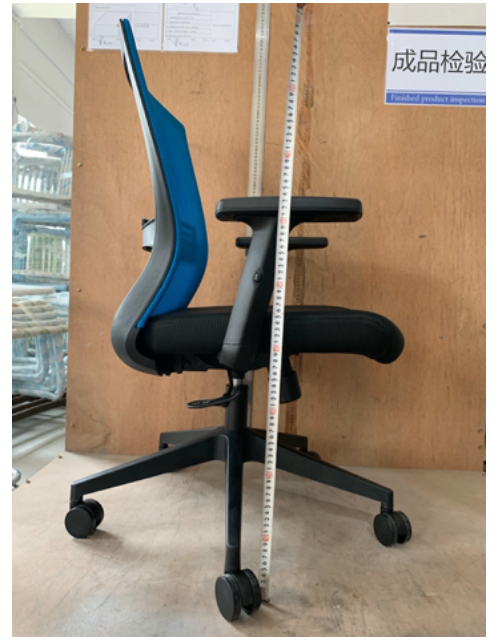
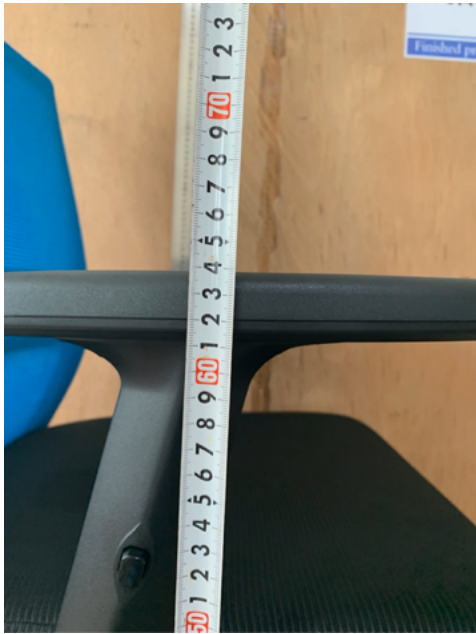
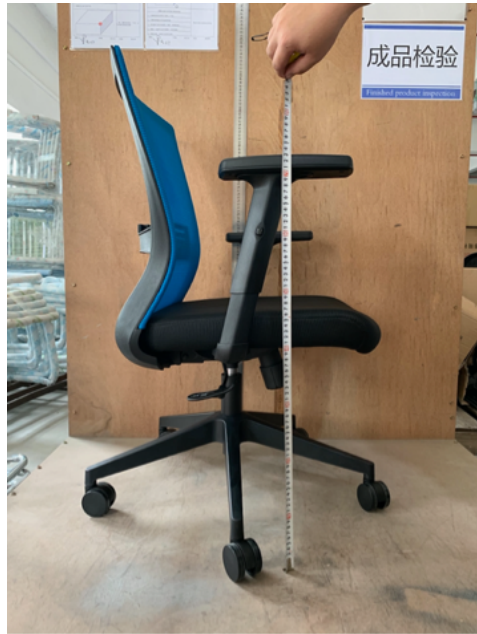
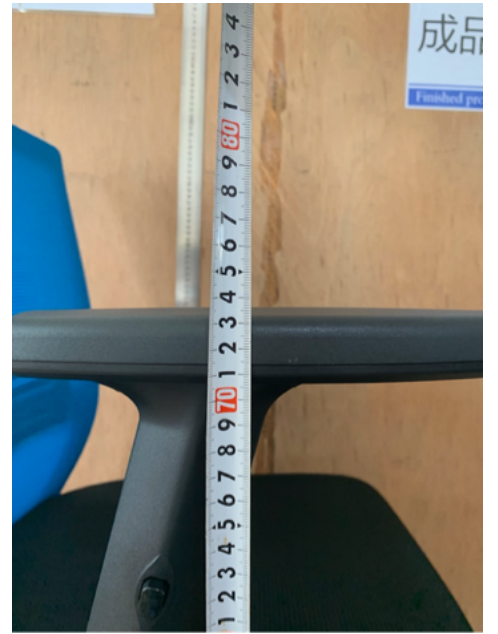
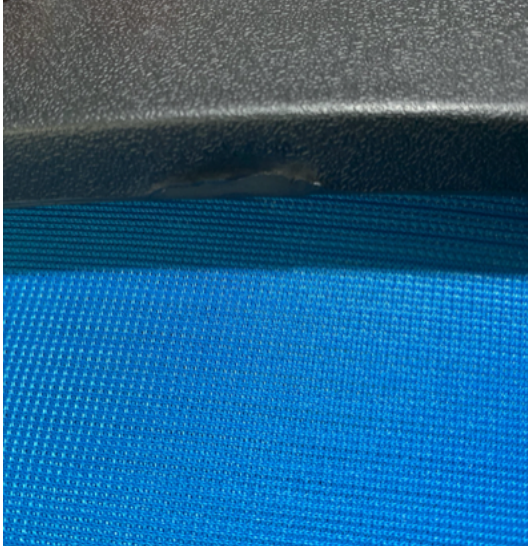
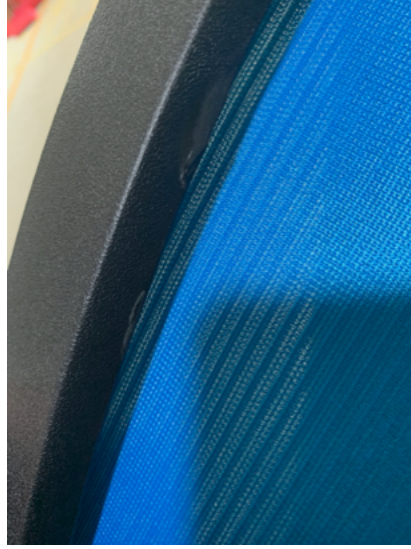
- Seat Height/General Remark:** seat height is approx. 1cm higher than provided measurement chart standard. See pictures #5 - #8 on pages 4 and 5. For other measurements, please refer to pictures #1 - #14 on pages 4 and 5.
- Mold Marks/General Remark:** same as per previous orders, mold marks found on the back side of the chair underneath the frame. While these marks are unavoidable, EWST team instructed the factory to smoothen out all the marks and add black spray if needed. See pictures #13 - #15 on page 6.
- Creases: the fabric on the seat had a slight crease in the centre, repaired on site. See picture #16 on page 6.
- Color Quality/General Remark:** the production's new blue color is very close to the last production's color. See pictures #17 - #18 on page 6.
